# Organic Waste Management Trial for the Shoalhaven Council using the BiobiN®

Onsite Forced Aeration Organic Waste Bin

Prepared by Stephen Willis  
Resourcefull Recycling  
1st March 2012

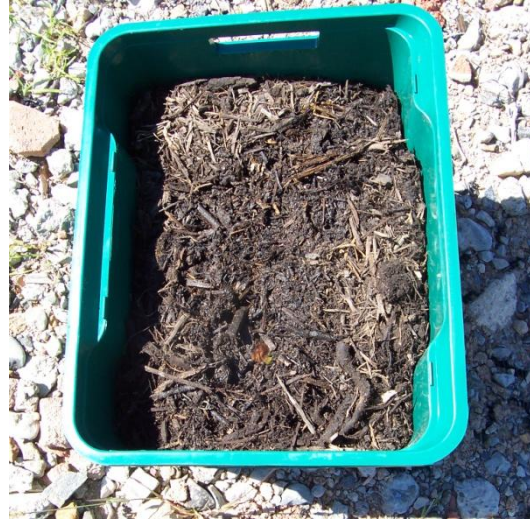
New compost starter

Due to the length of the journey the compost starter had dried out. New compost material was selected, wet down and inserted into the BiobiN®.

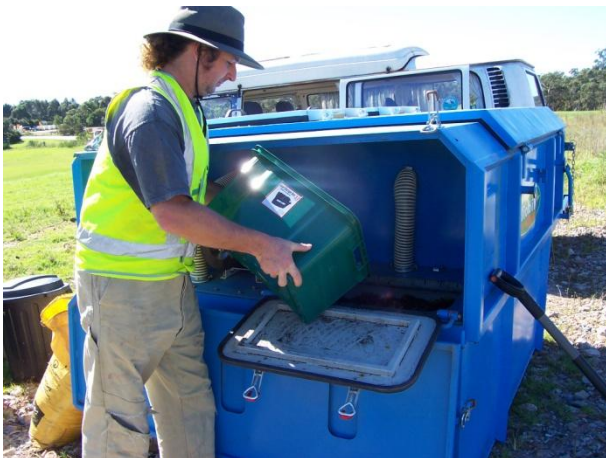
Compost microbe inoculum being placed in the compost starter hopper on the side of the BiobiN®.

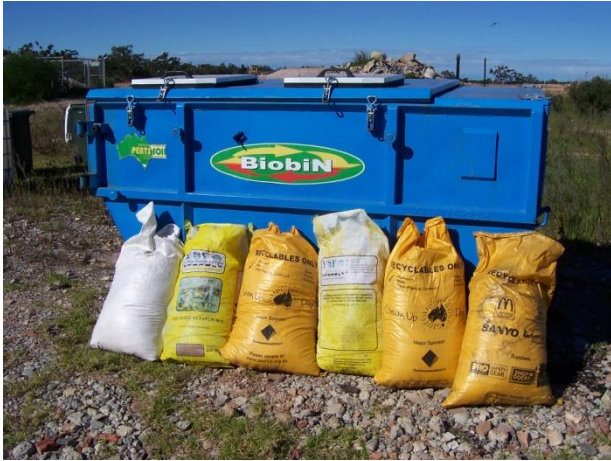
Bags of sawdust in front of the BiobiN®. This is a waste product from a local saw mill.

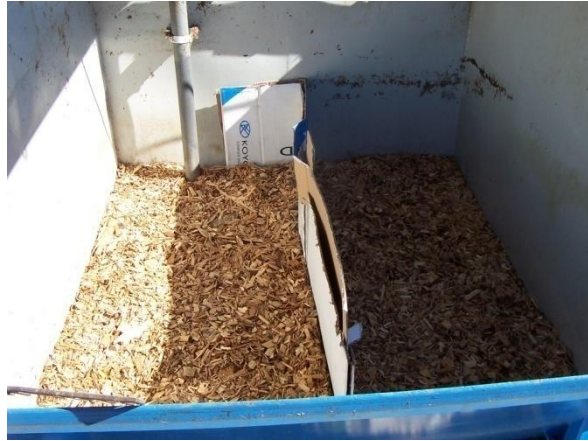
The BiobiN® is supplied with woodchips on the base. This is on top a piece of steel mesh which covers the aeration pipes.

The bin was simply divided into two by using a piece of cardboard to separate the areas.

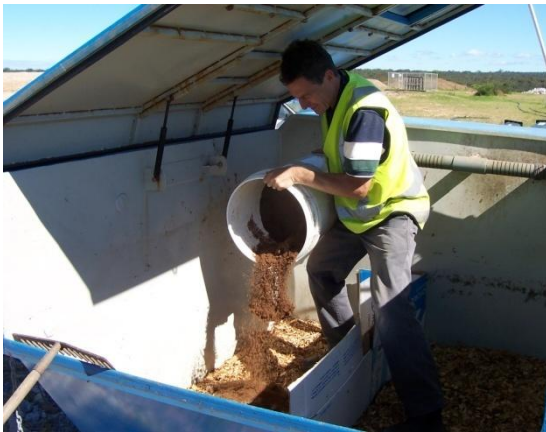
Adding bokashi fermentation on top of the woodchip. Pictured right – woodchip covered with a thin layer of the bokashi.

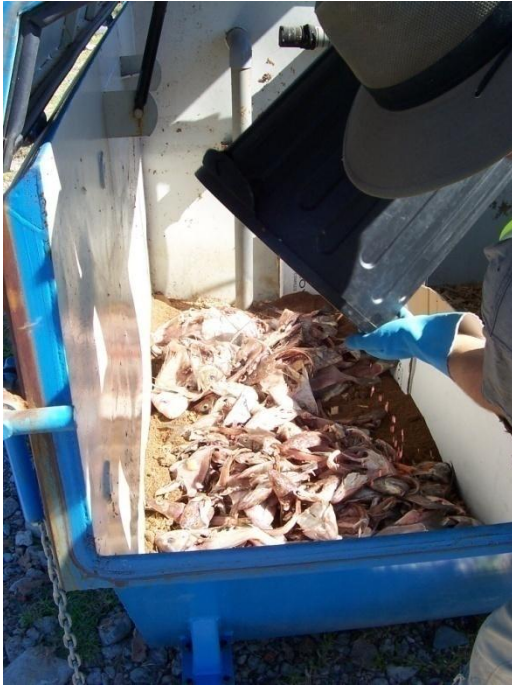
About 80 litres of unprocessed fish waste was spread out over the area using a rake.

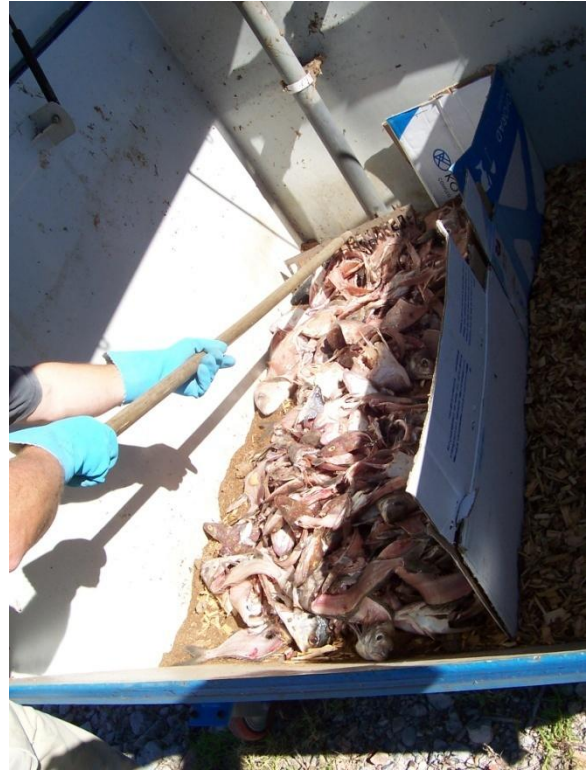
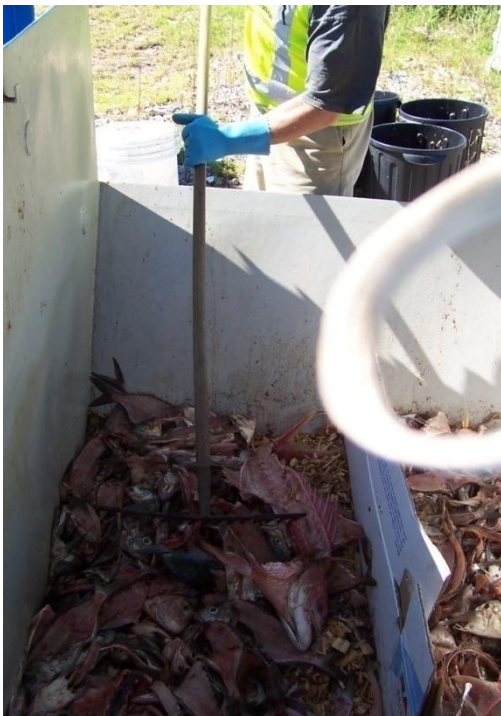
Filling the other side with fish waste.

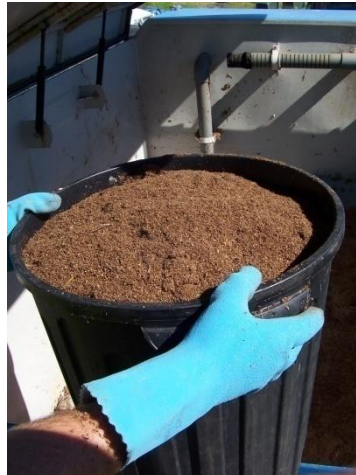
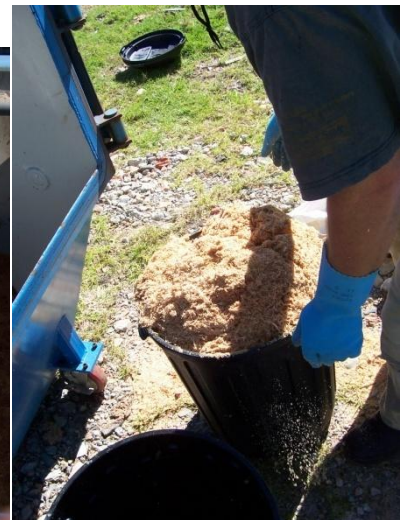
Bokashi & Sawdust was measured out using a 60 litre garbage bin. Both the sawdust and bokashi was added at a ratio of 1.5 times the volume of the fish waste (80 litres fish waste: 120 litres sawdust or bokashi)

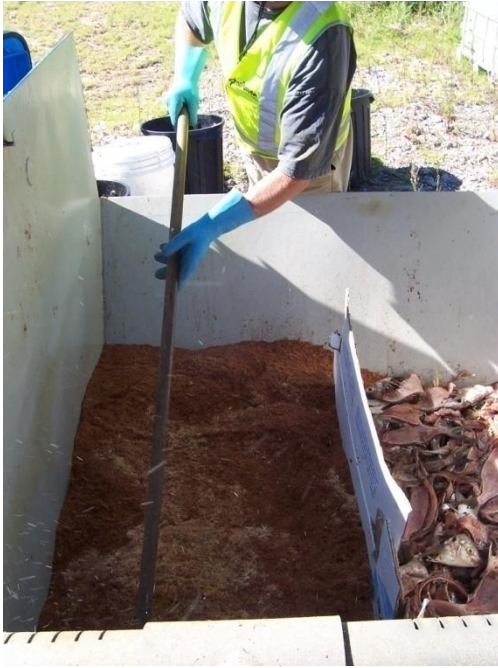
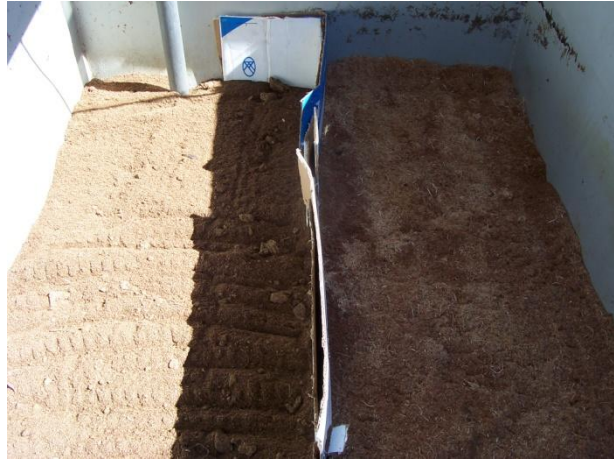
The sawdust and bokashi was raked out over the fish waste to make sure even and complete coverage was achieved.

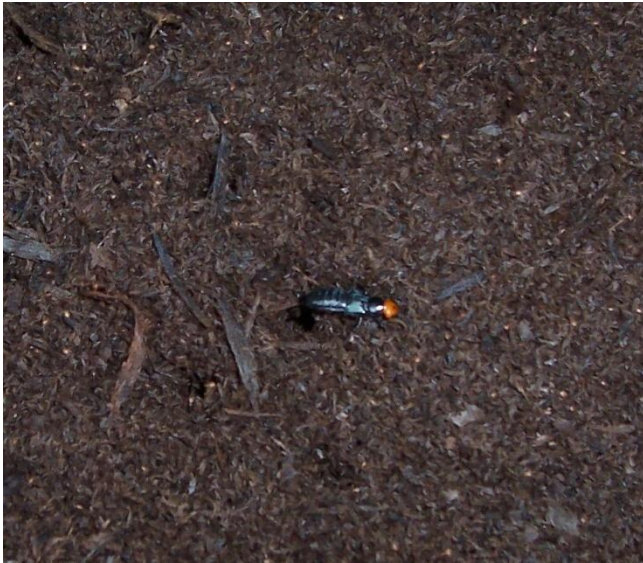
A rove on the emerging from a hole in the surface of the top layer of sawdust.

**Rove Beetles** – Small beetles 10 – 15mm long were discovered living happily in the sawdust fish mix in the BiobiN®. These were identified as being Rove Beetles.

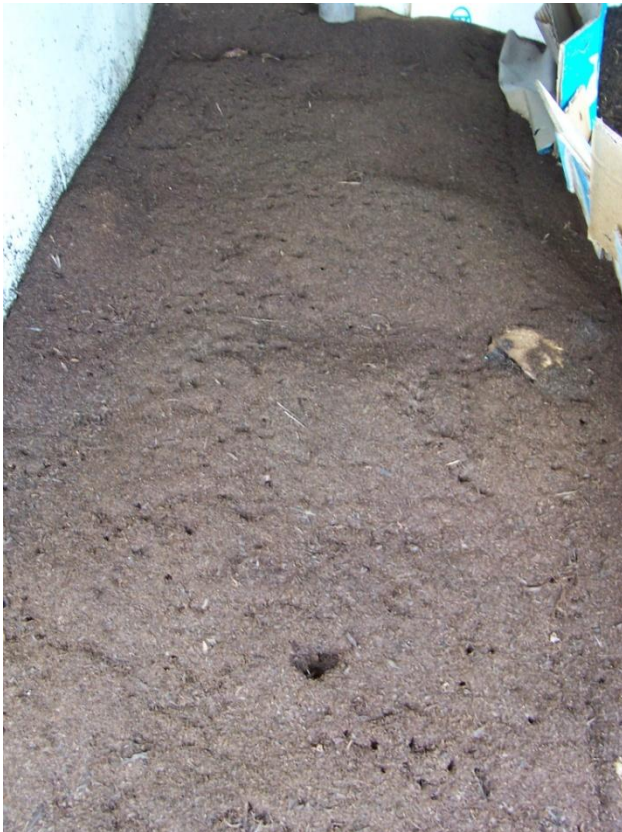
The dark holes have been made by the rove beetles. They probably came in the sawdust. Amazingly they are thriving in this environment, filled with ammonia and long periods of the fan forced air.

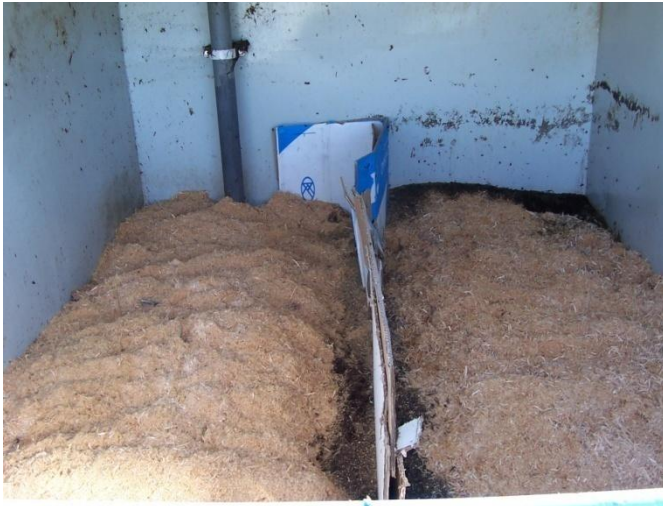
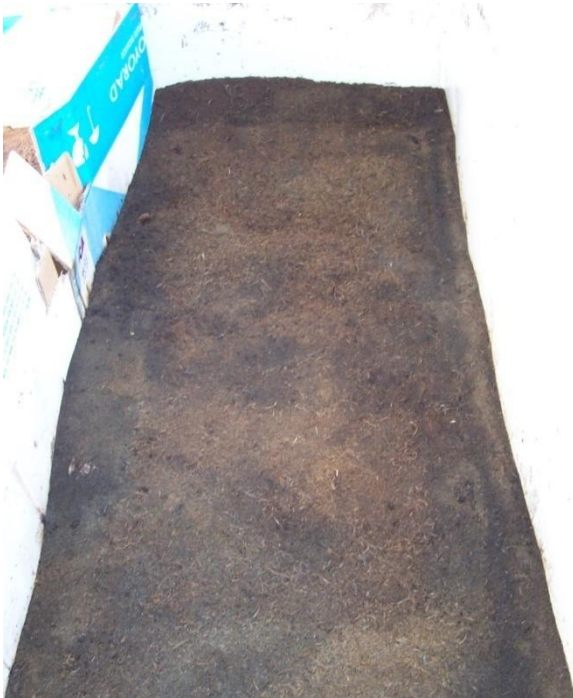
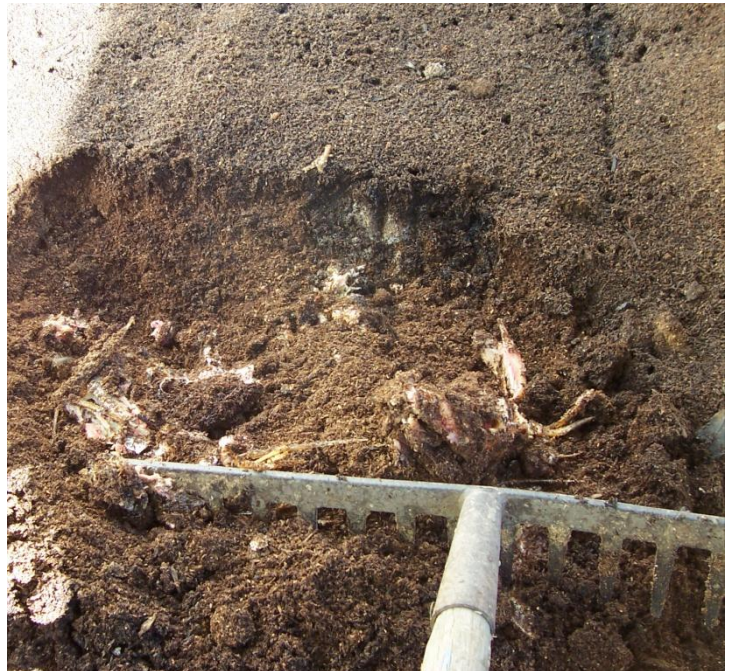
This series of three photos show how the sawdust and the fish waste changes over one week. Pictured left is the new sawdust layered on top of the fish waste.

Below left - show the darkened sawdust through moisture and bio-transformation interacting with the fish waste.

Below right - shows a cut away section of the last layer of fish and sawdust. There is a darkened moist area on top where you can see the holes made by the Rove beetle. The sawdust immediately around the fish is drier than the top layer. A large proportion of the flesh on the fish frames has decomposed. The remaining flesh has come from area where the flesh is denser like the fish head.

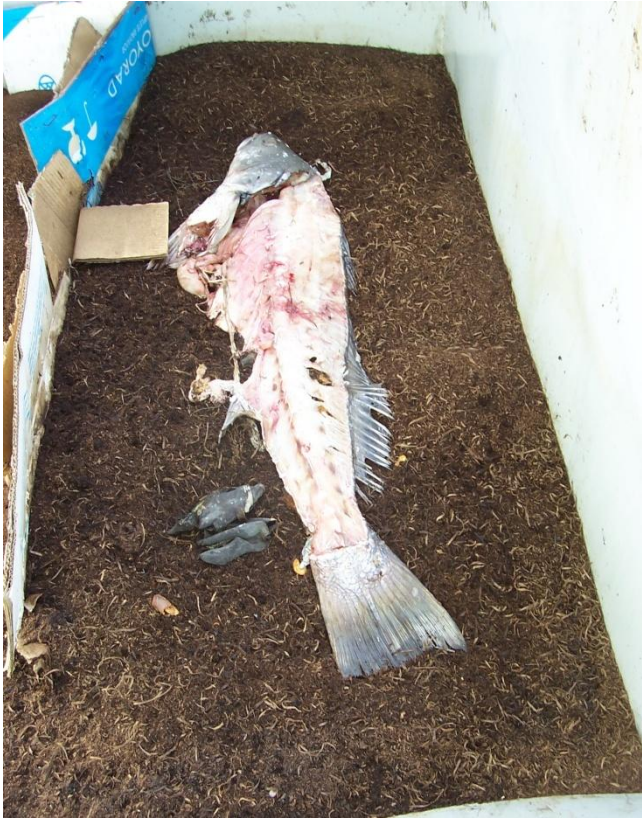
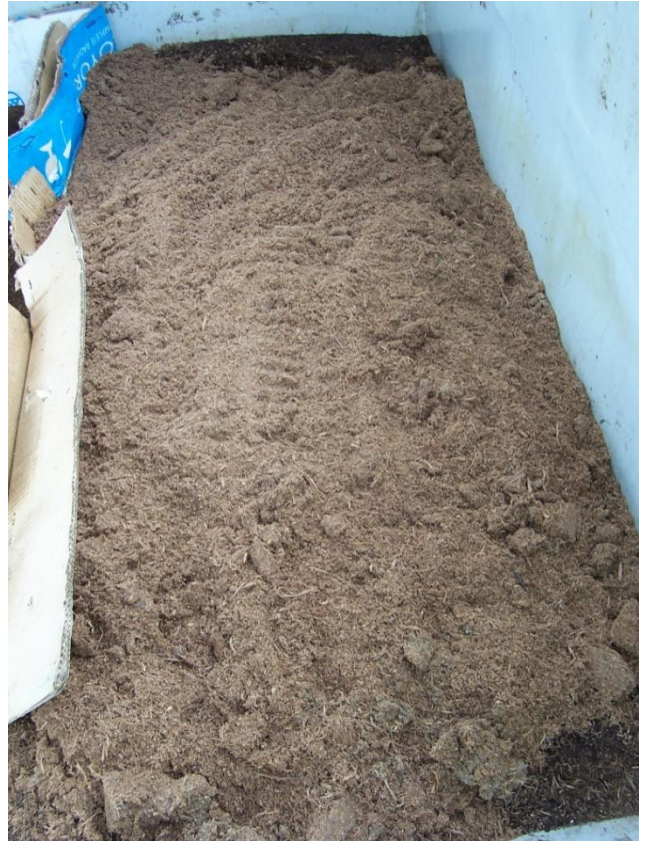
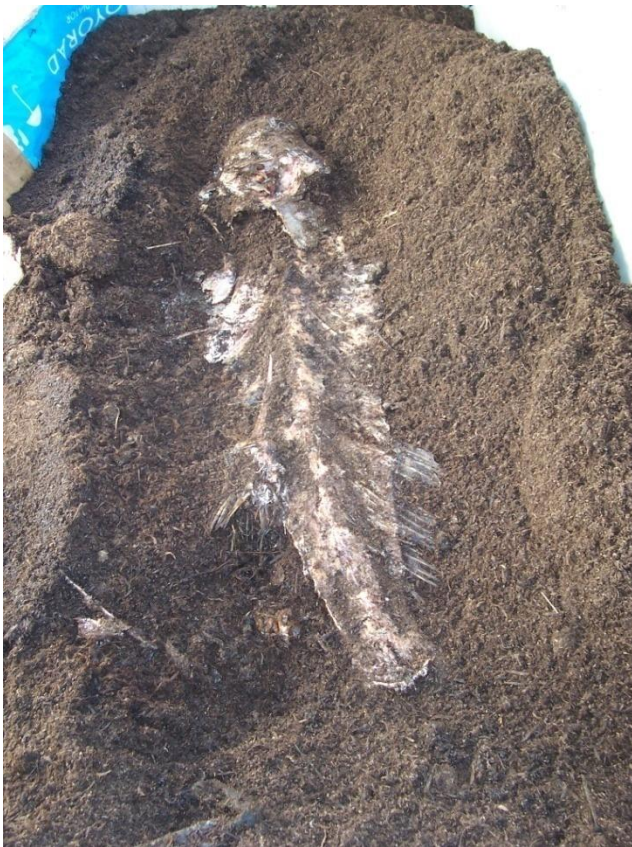
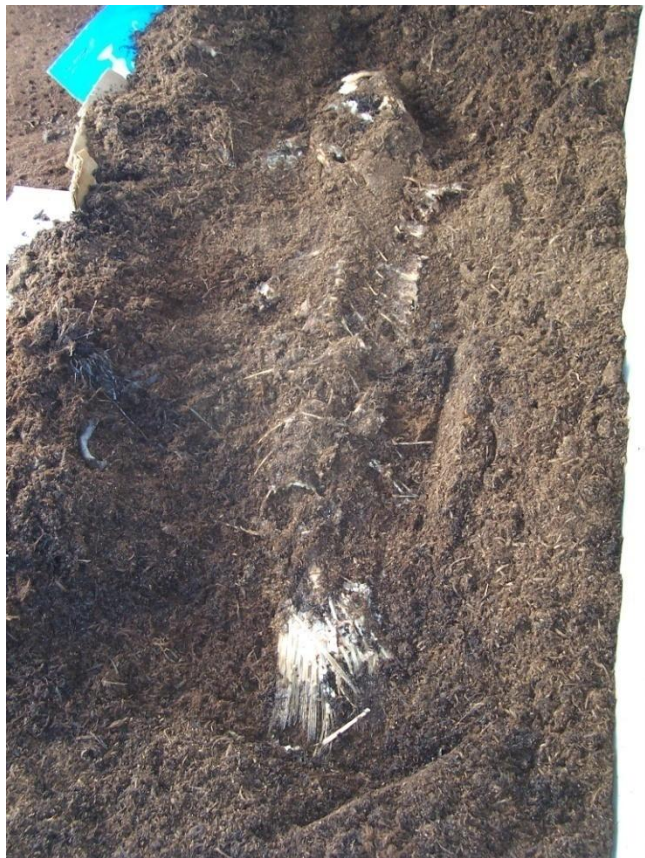
Below are photos of the decomposition of a large fish over a couple of week. This fish had fillets removed with the head, skeleton and fins still in tact. Flesh attached to the exposed skeleton disappeared quickly. Areas where the flesh was thick, like the head, took longer to breakdown. Small bones were digested faster than the head or tail.

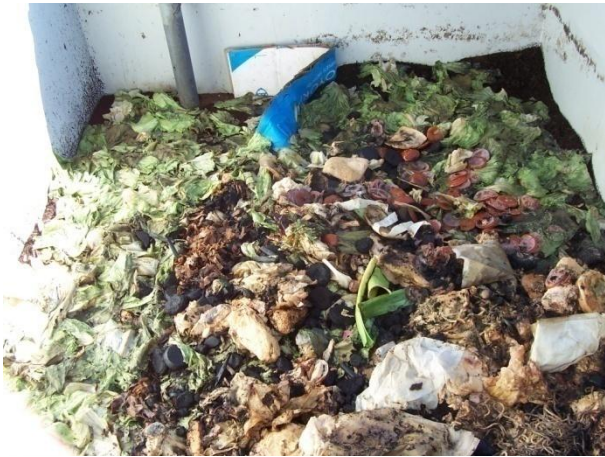
The food waste material spread across the bin.

To assist the digestion of the food waste, cardboard was added in layer to balance carbon and nitrogen elements in the BiobiN® and to absorb moisture as it was liberated from vegetables under the forced aeration digestion process. This worked well.

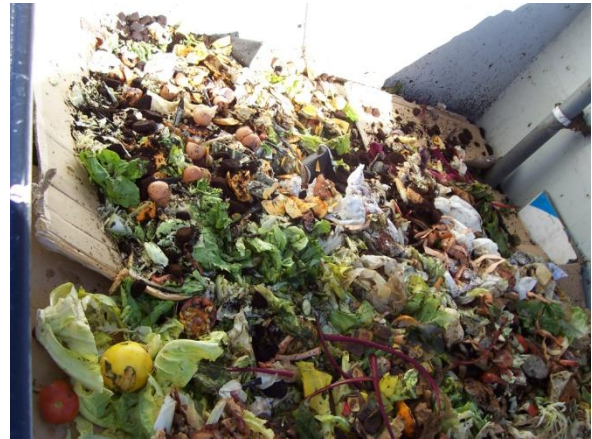
You can see a layer of cardboard under the food waste.

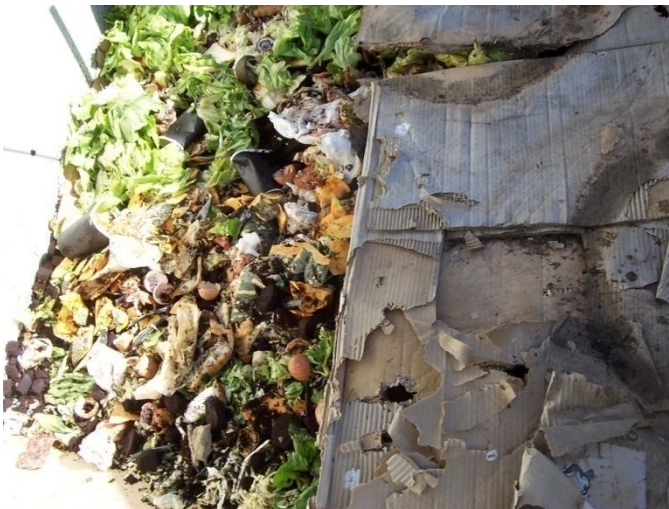
The food waste was then covered with cardboard and paper. This was added as carbon layer to balance the nitrogen food waste. Cardboard packaging boxes and office paper was used. This was generated from the various sites.

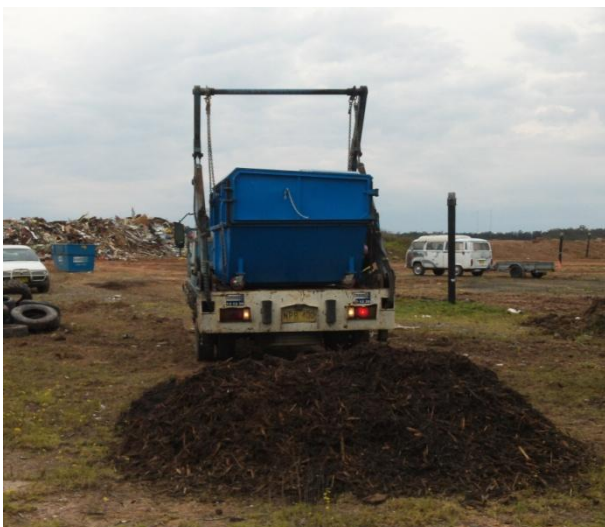
BiobiN® ready to empty its contents. It was mixed with the shredded green waste in the foreground.

The final step of the project was to empty the contents of the BiobiN® and observe decomposition and smell. The material was then mixed with shredded green waste.

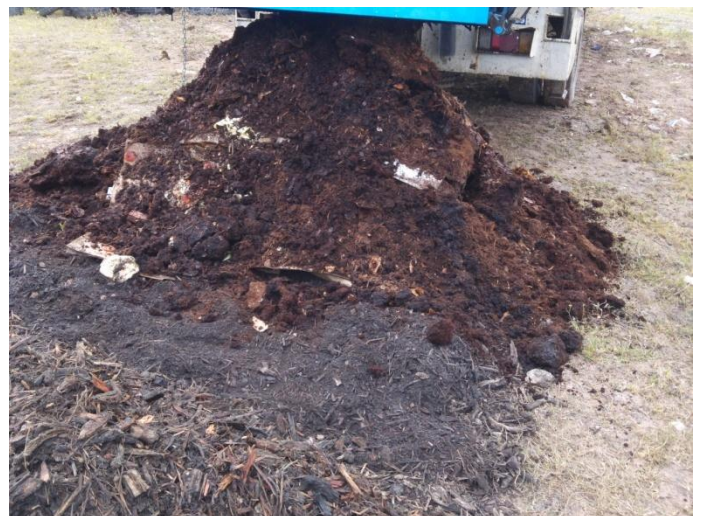
Contents from the BiobiN® showing varying degrees of decomposition.
